A & R DEPARTMENT NARRATIVE CODE SHEET

NASC:113:dj
Ser: 965
25 April 1963

Subj: VX-5 AAR ser 1-62 concerning A-4C (A4D-2N) BuNo 145066 accident
occurring 25 September 1962, pilot (b) (6)

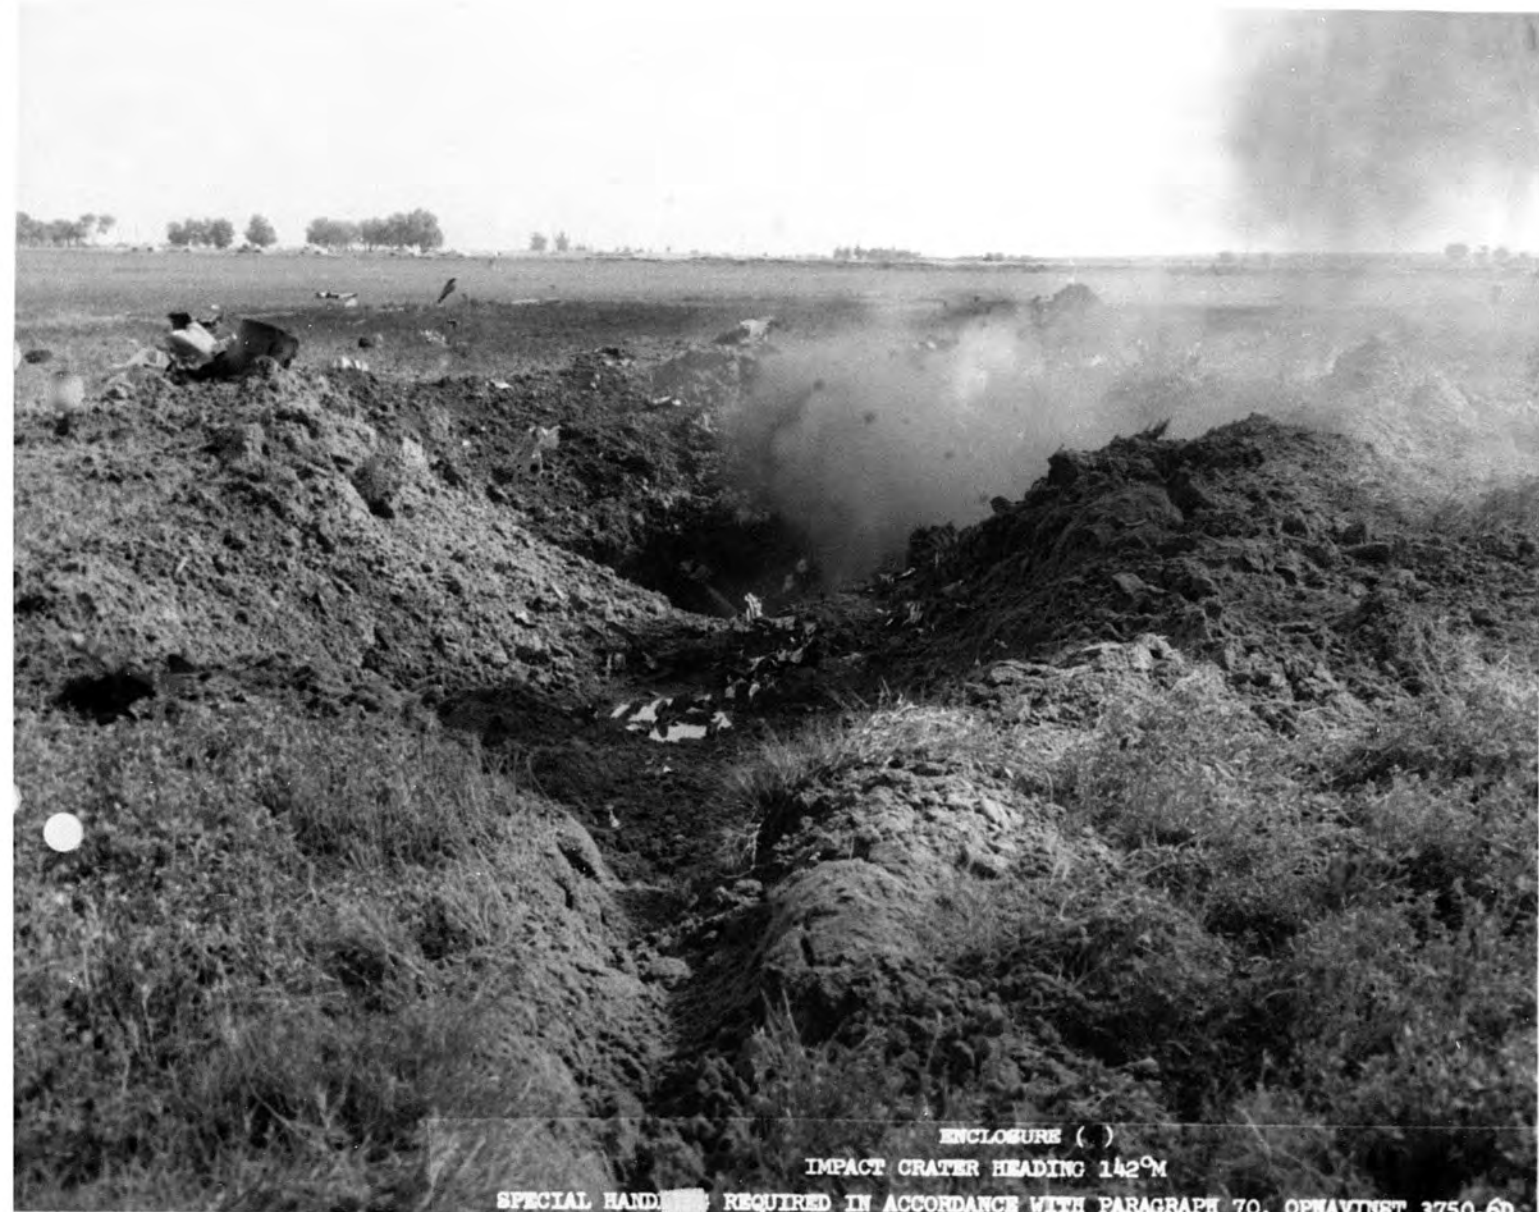
IMPACT CRATER HEADING 142°M

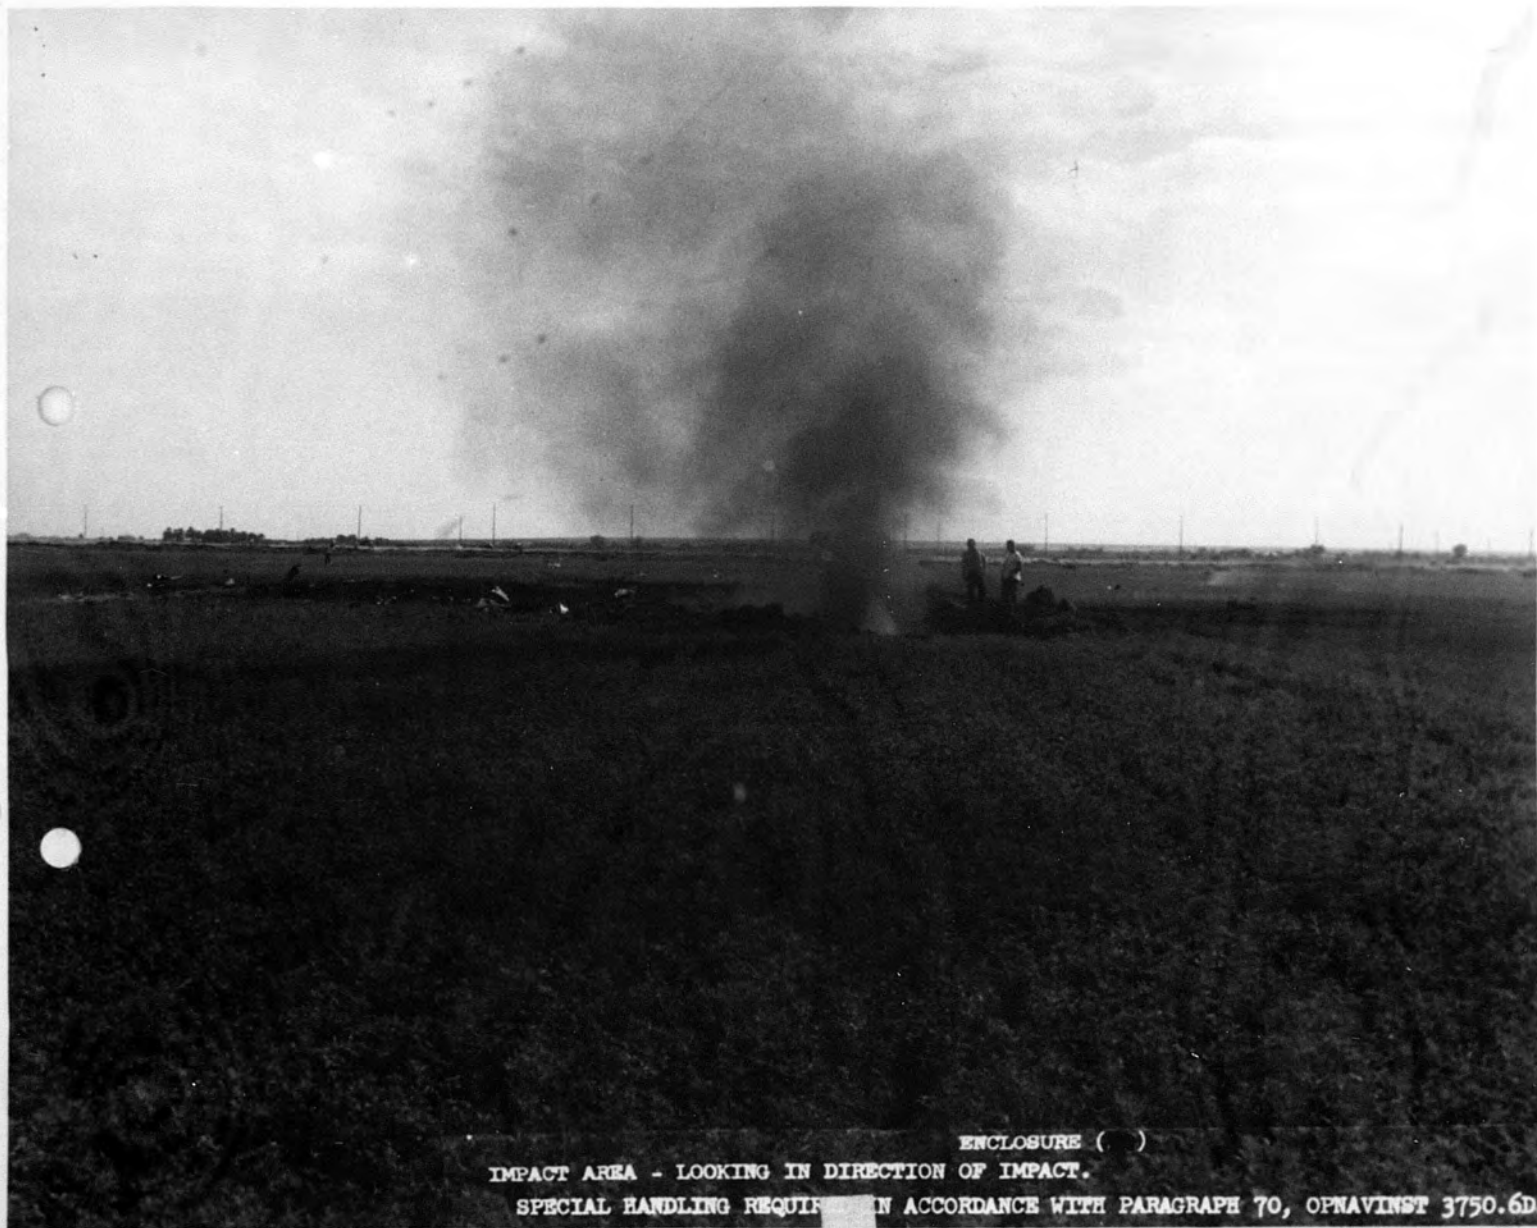
IMPACT AREA - LOOKING IN DIRECTION OF IMPACT.

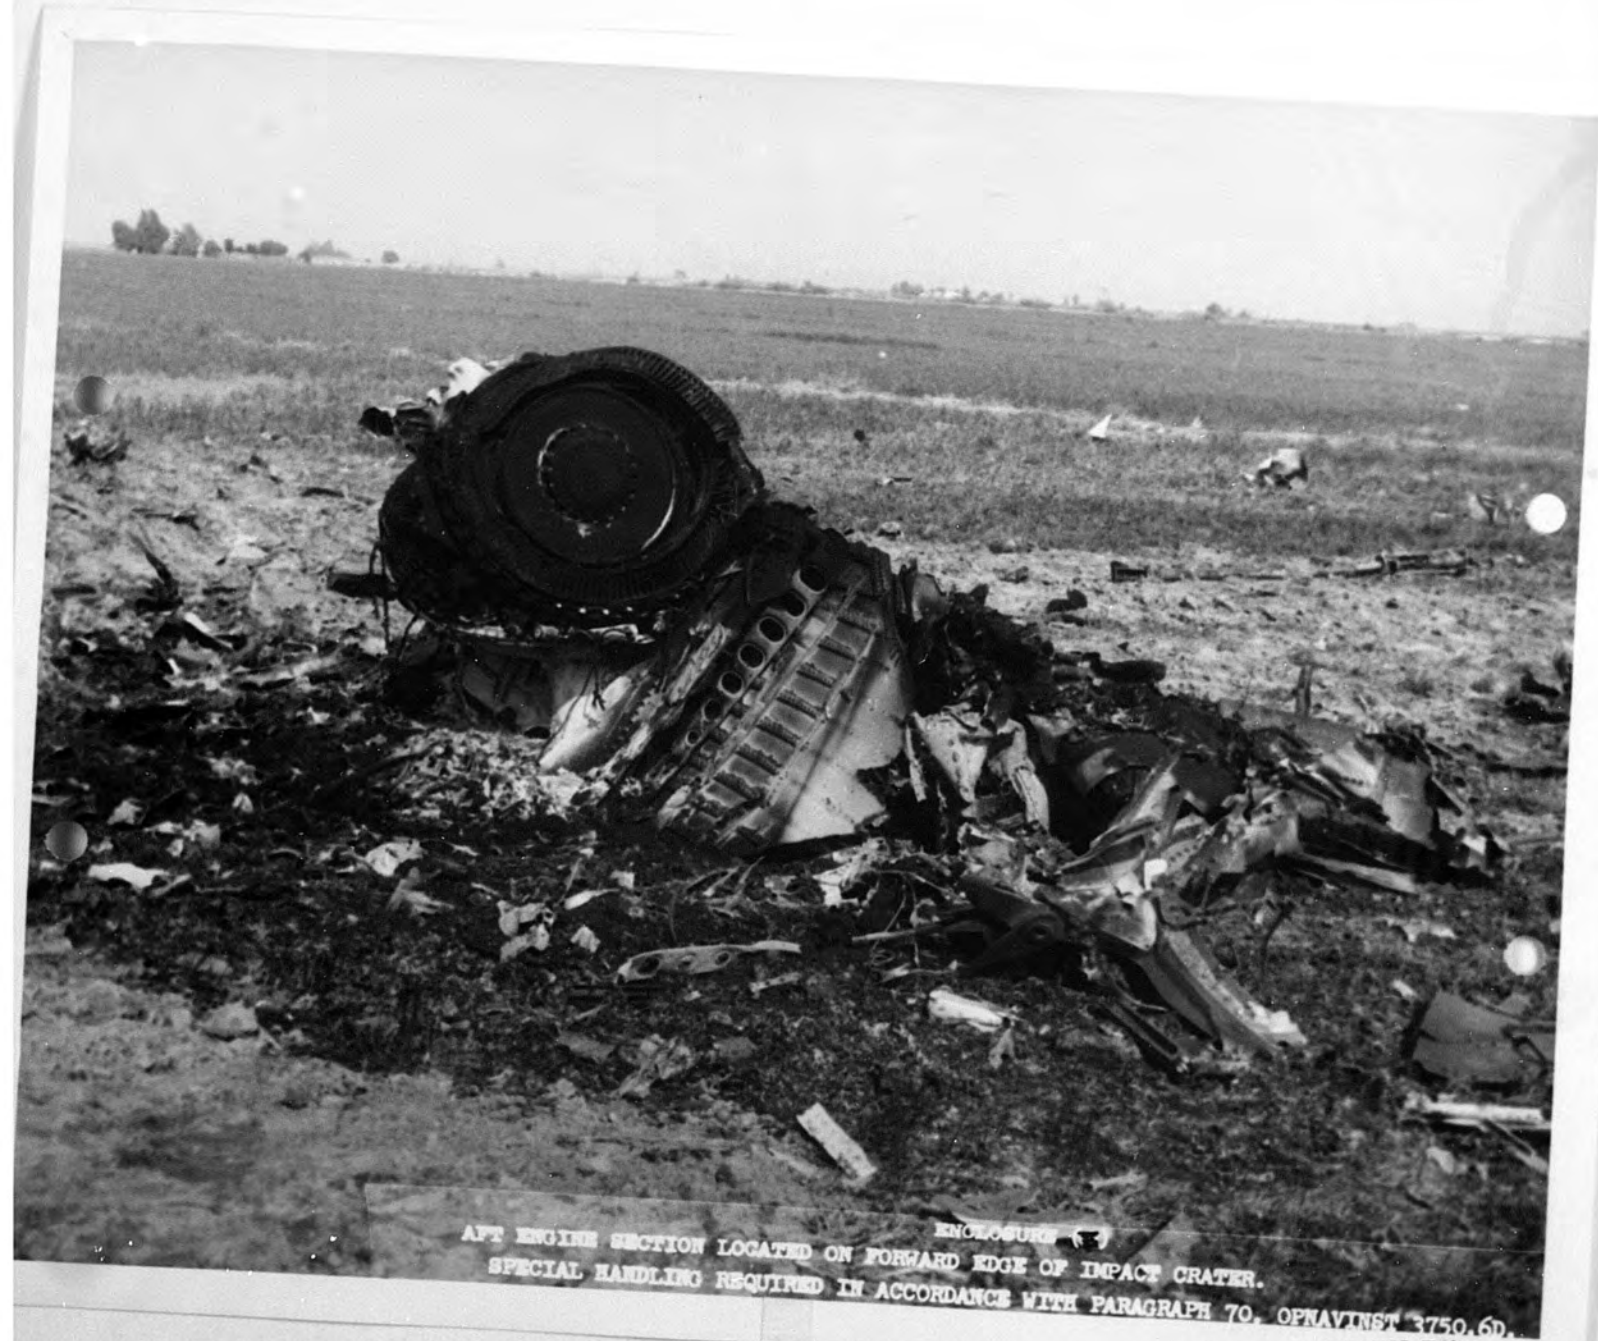
ENCLOSURE (7)
AFT ENGINE SECTION LOCATED ON FORWARD EDGE OF IMPACT CRATER.
SPECIAL HANDLING REQUIRED IN ACCORDANCE WITH PARAGRAPH 70, OPNAVINST 3750.60.

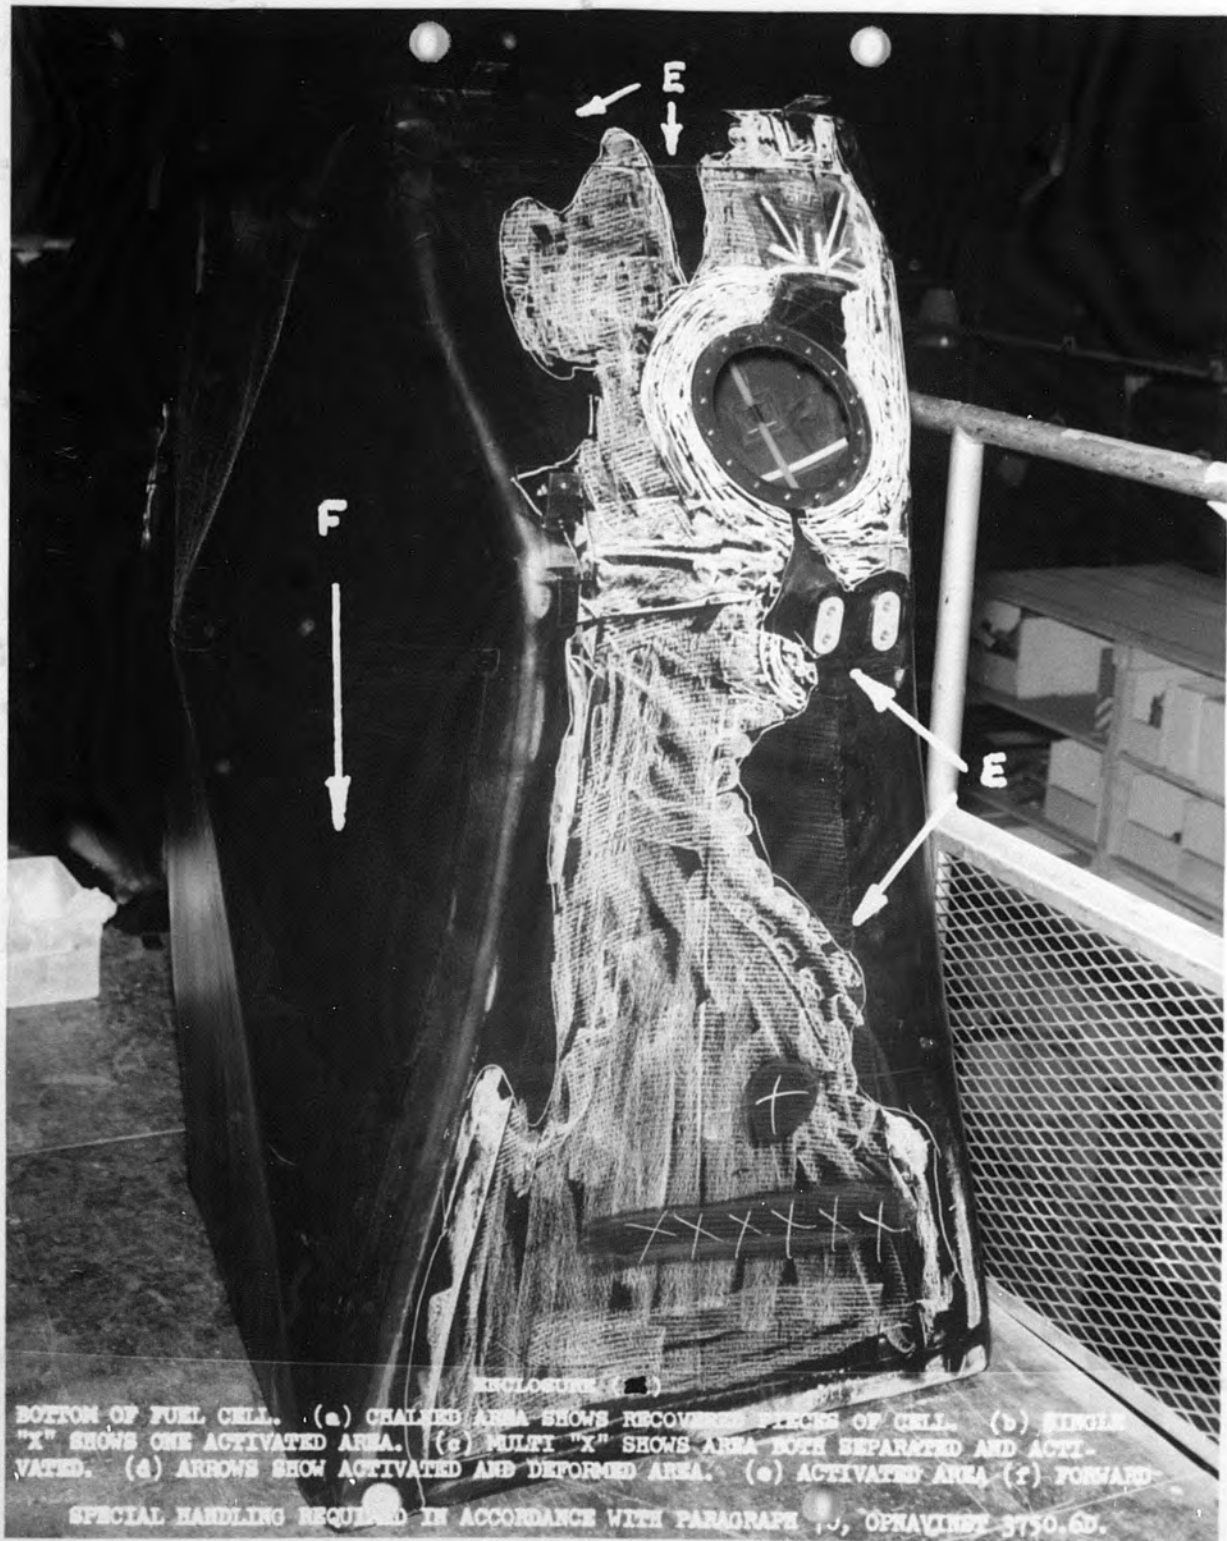
ENCLOSURE (2)

Examination of the bottom of the cell revealed several areas of activation, one large area of tank separation and one area of deformation. (see enclosures (12-17)). From pieces of the fuel cell it was determined that only the activated (fuel soaked) areas had burned. Enclosures (12&13) clearly shows that the fuel cell did not burn beyond the activated area.

BOTTOM OF FUEL CELL. (a) CHAINED AREA SHOWS RECOVERED PIECES OF CELL. (b) SINGLE "X" SHOWS ONE ACTIVATED AREA. (c) MULTI "X" SHOWS AREA BOTH SEPARATED AND ACTIVATED. (d) ARROWS SHOW ACTIVATED AND DEFORMED AREA. (e) ACTIVATED AREA (f) FORWARD SPECIAL HANDLING REQUIRED IN ACCORDANCE WITH PARAGRAPH 3, OPNAVINST 3750.60.

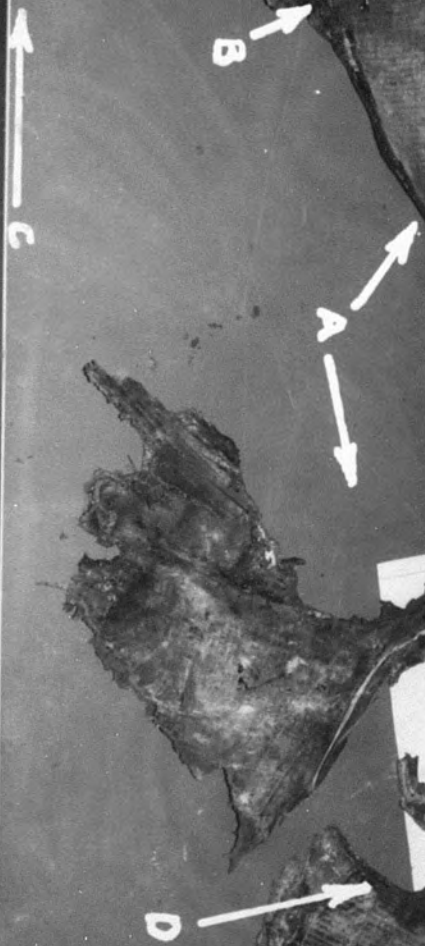
BOTTOM OF FUEL CELL - OUTSIDE. (a) ACTIVATION (b) ACTIVATION AND SEPARATION (c) FORWARD (d) DEFORMATION AND ACTIVATION.

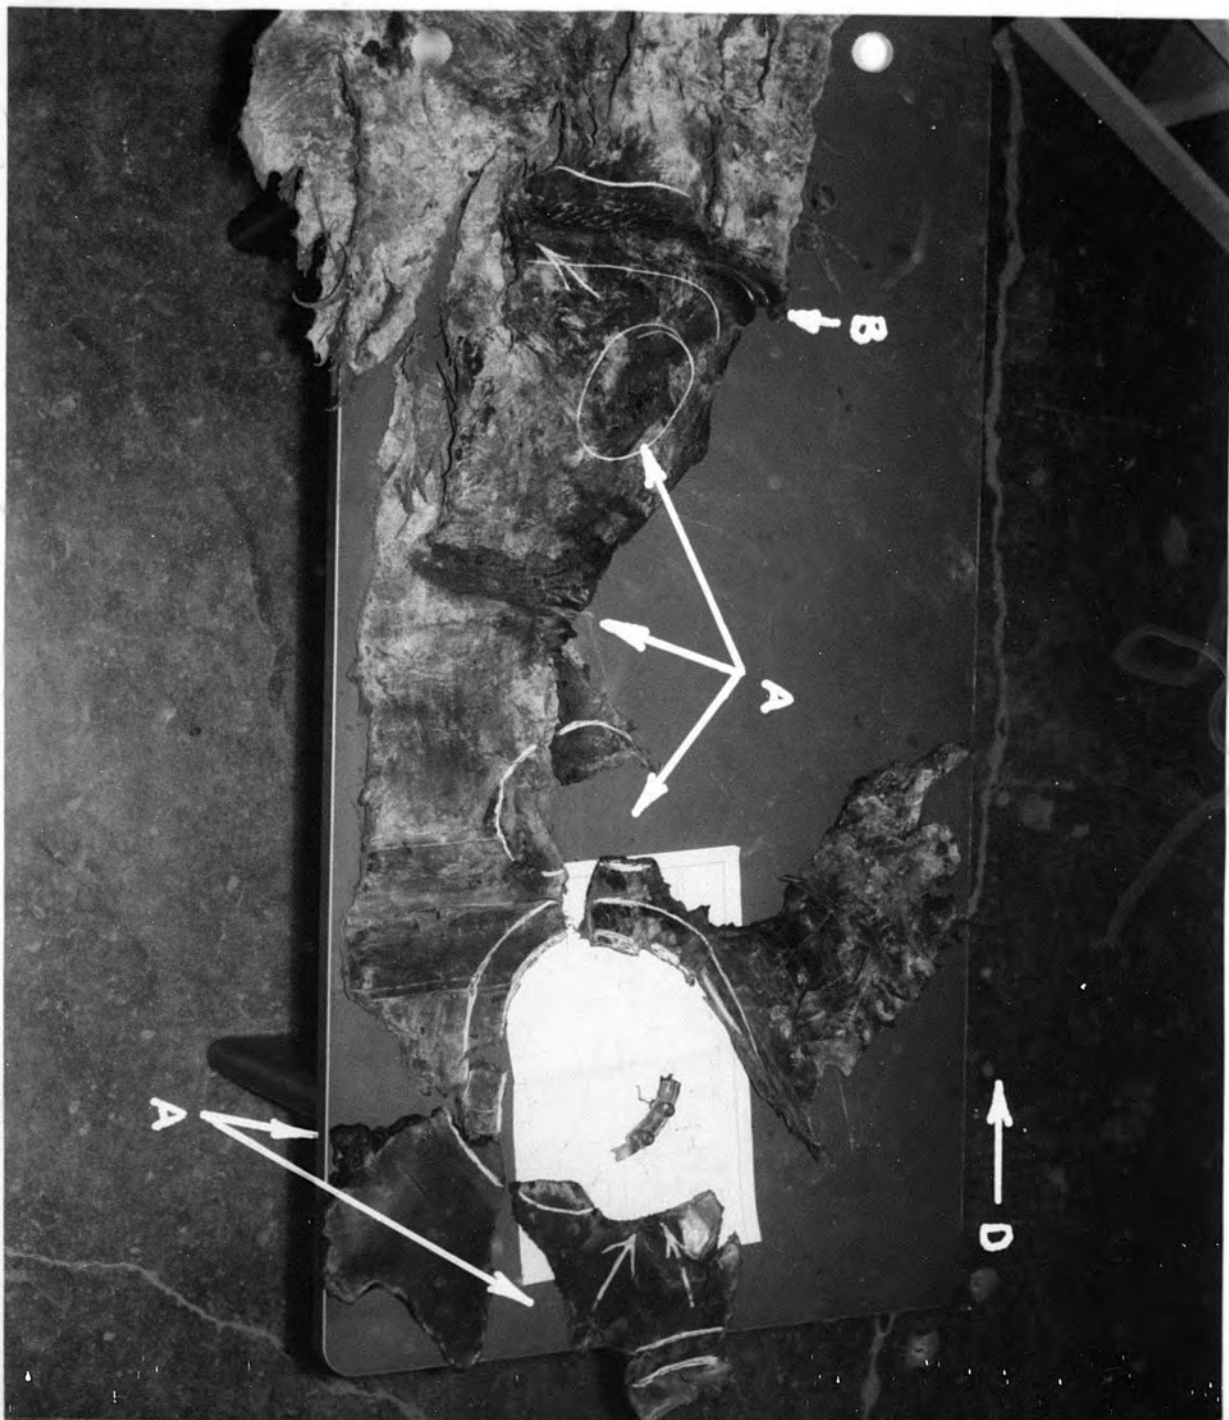
BOTTOM OF FUEL CELL - INSIDE. ARROWS SHOW ACTIVATED AND DEFORMED AREA. (a) ACTIVATED AREA (b) ACTIVATION AND SEPARATION (c) FORWARD.

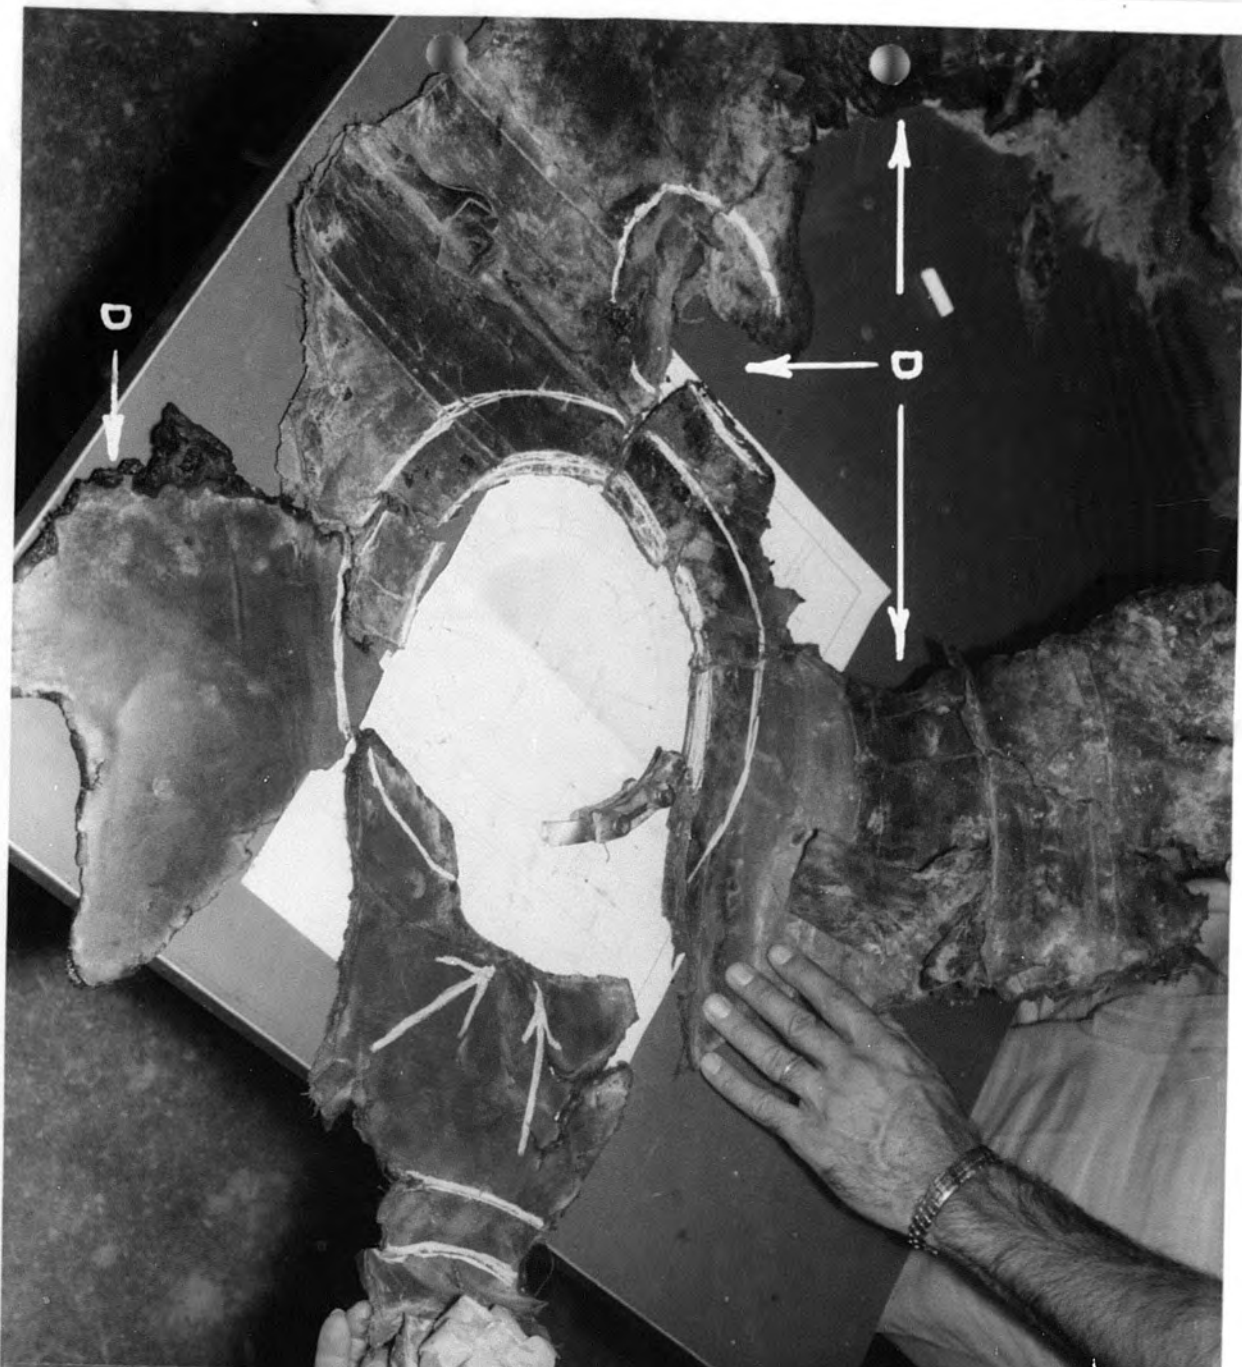
A potential cause of chafing and deformation of the fuselage fuel cell bottom is installation of the fuel Boost pump bracket assembly in an inverted position. One squadron A4D-1 was found to have this "inverted" installation after all squadron airplanes had been subjected to a fuel cell and cell support inspection following the accident. This A4D-1 had completed PAR in August 1961.

BOTTOM OF FUEL CELL - INSIDE. CLOSE UP OF FUEL BOOST PUMP AREA. (a) ARROWS SHOW AREA OF ACTIVATION AND DEFORMATION. (b) OUTLINED AREA OF CELL LAYED OVER BLUEPRINT SHOWS BOOST PUMP FLANGE AREA. (c) OUTLINED AREA AT TOP OF PICTURE SHOWS CELL MOUNTING AREA (d) ACTIVATED AREA.

It is recommended that all A4D fuselage fuel cells be removed at every PAR period and be thoroughly inspected. It is further recommended that consideration be given to increasing the width of the fuel boost pump bracket (Part No. 3665809) for increased support for the fuel cell in this area.

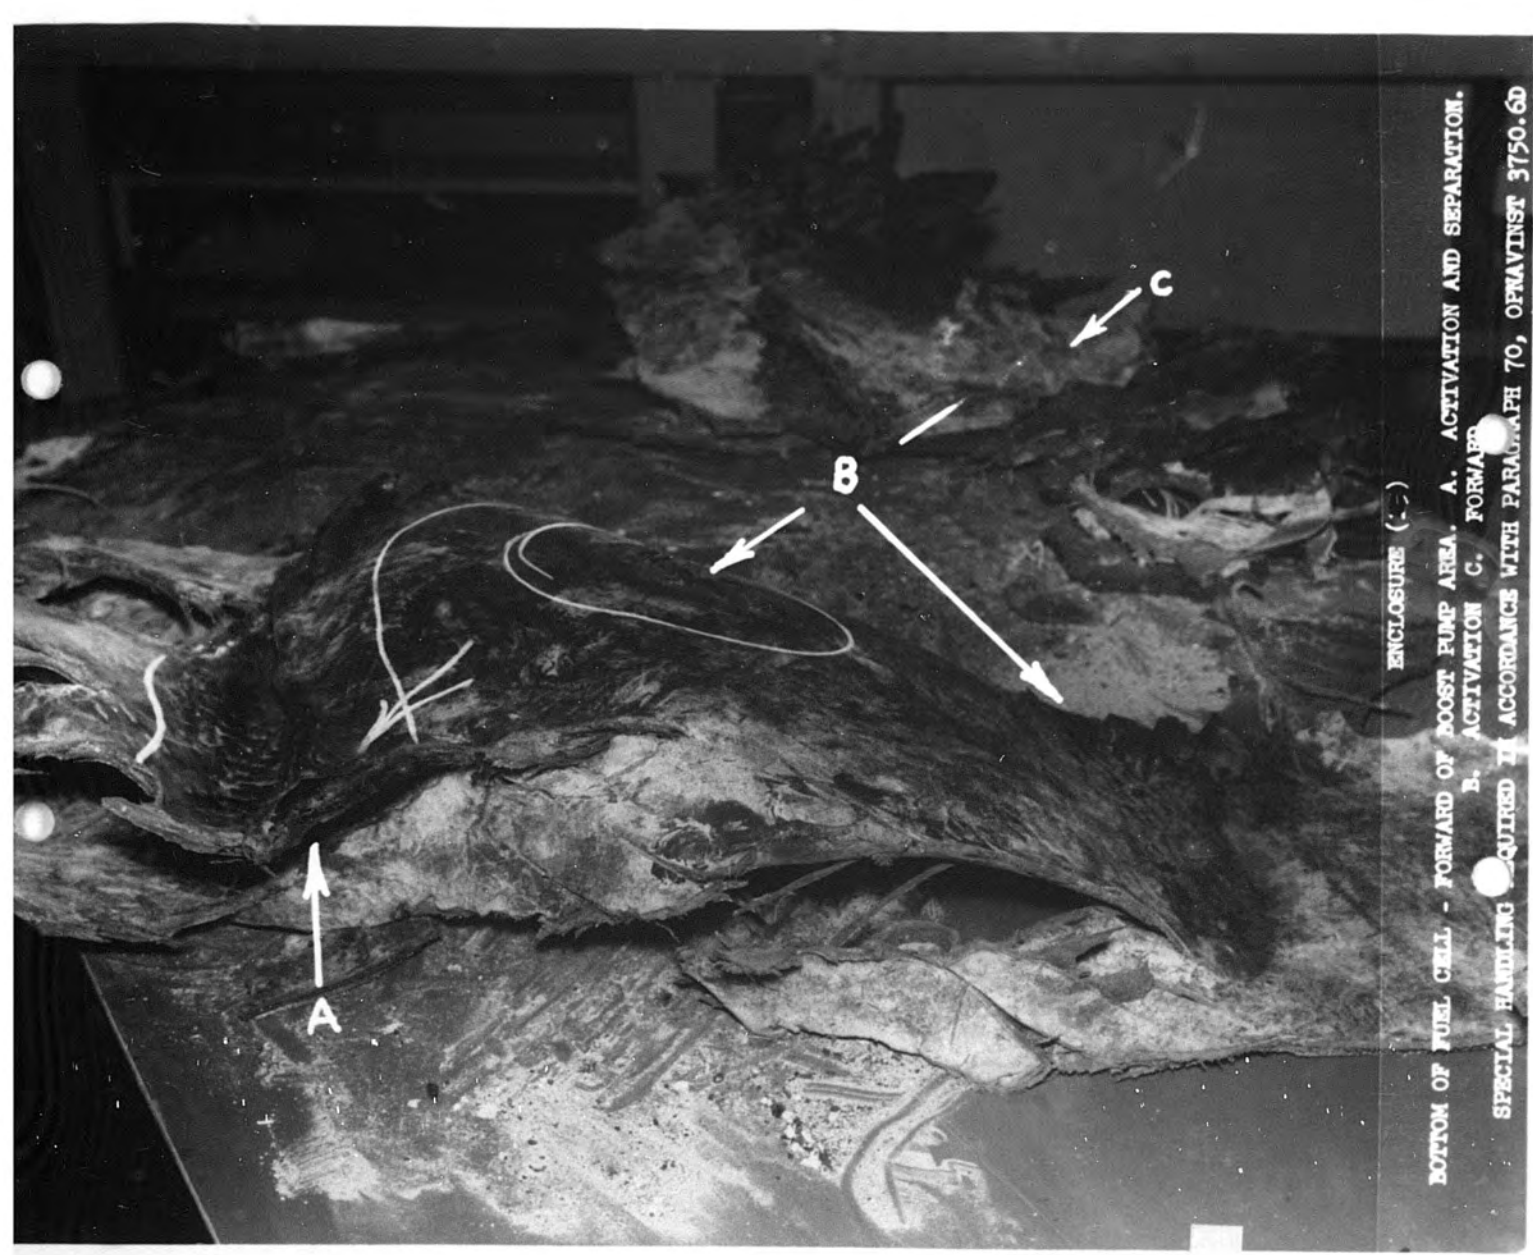
BOTTOM OF FUEL CELL - FORWARD OF BOOST PUMP AREA. A. ACTIVATION AND SEPARATION.

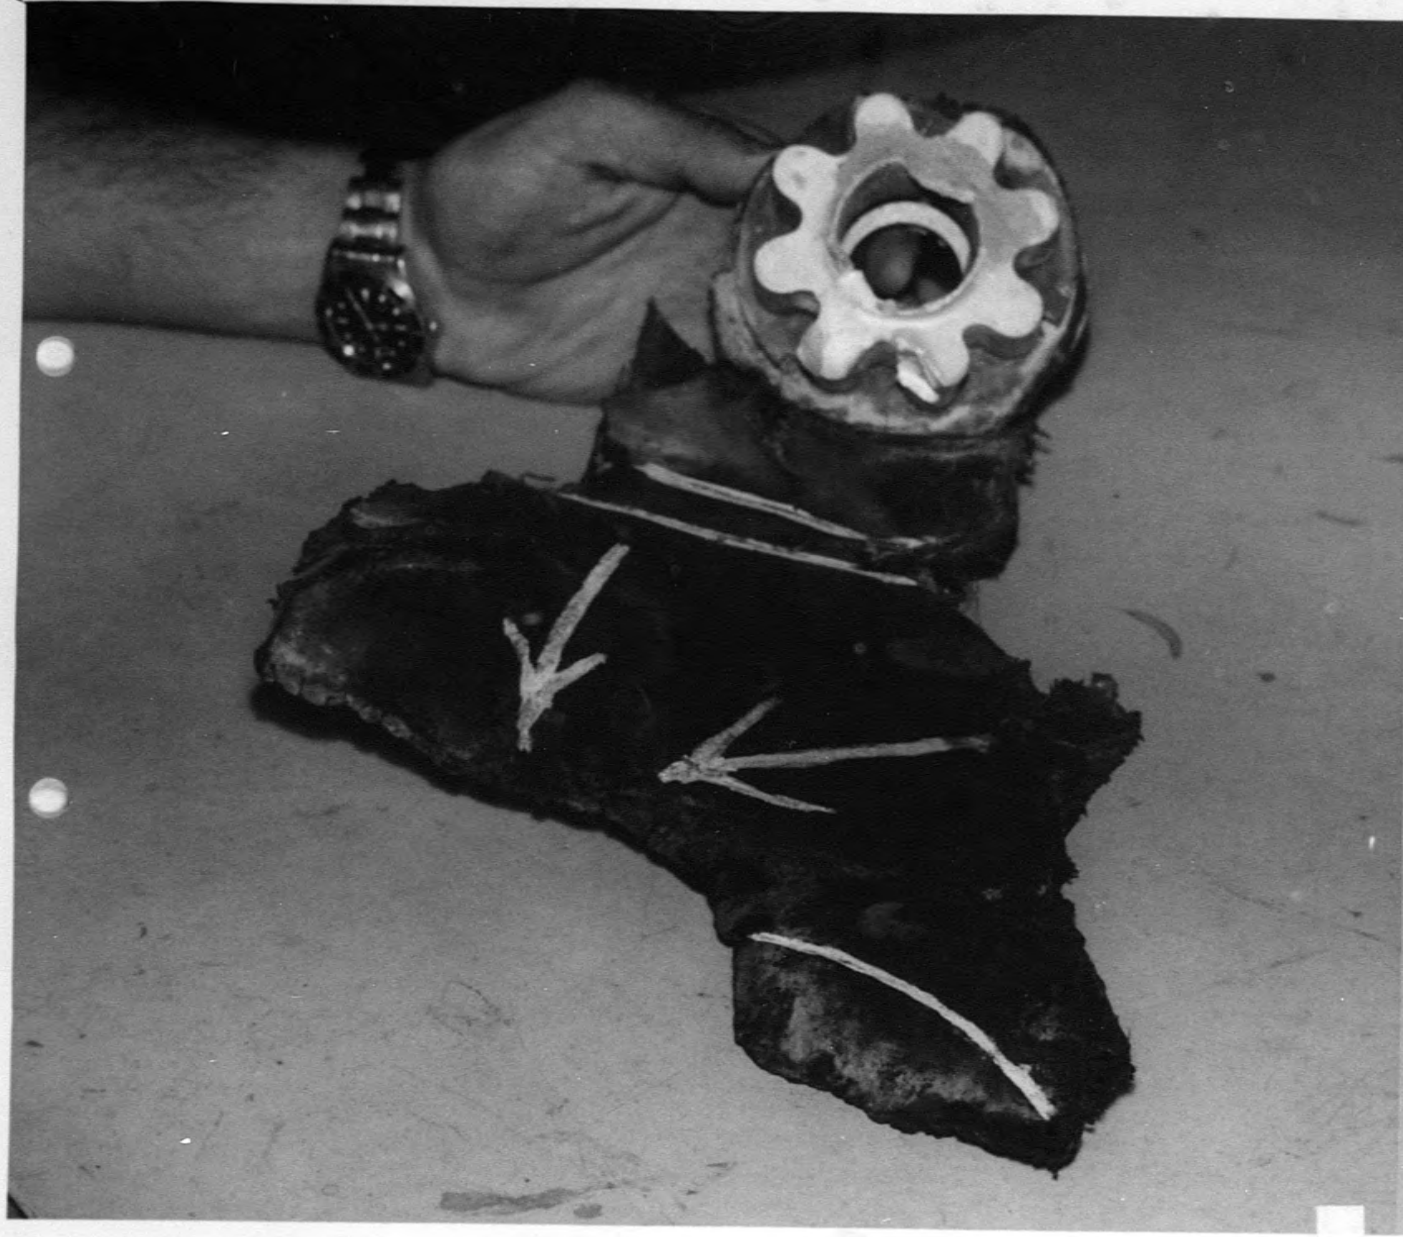
DEFORMATION OF FUEL CELL (INSIDE) JUST AFT OF THE BOOST PUMP. ARROWS SHOW ACTIVATED AND DEFORMED AREA

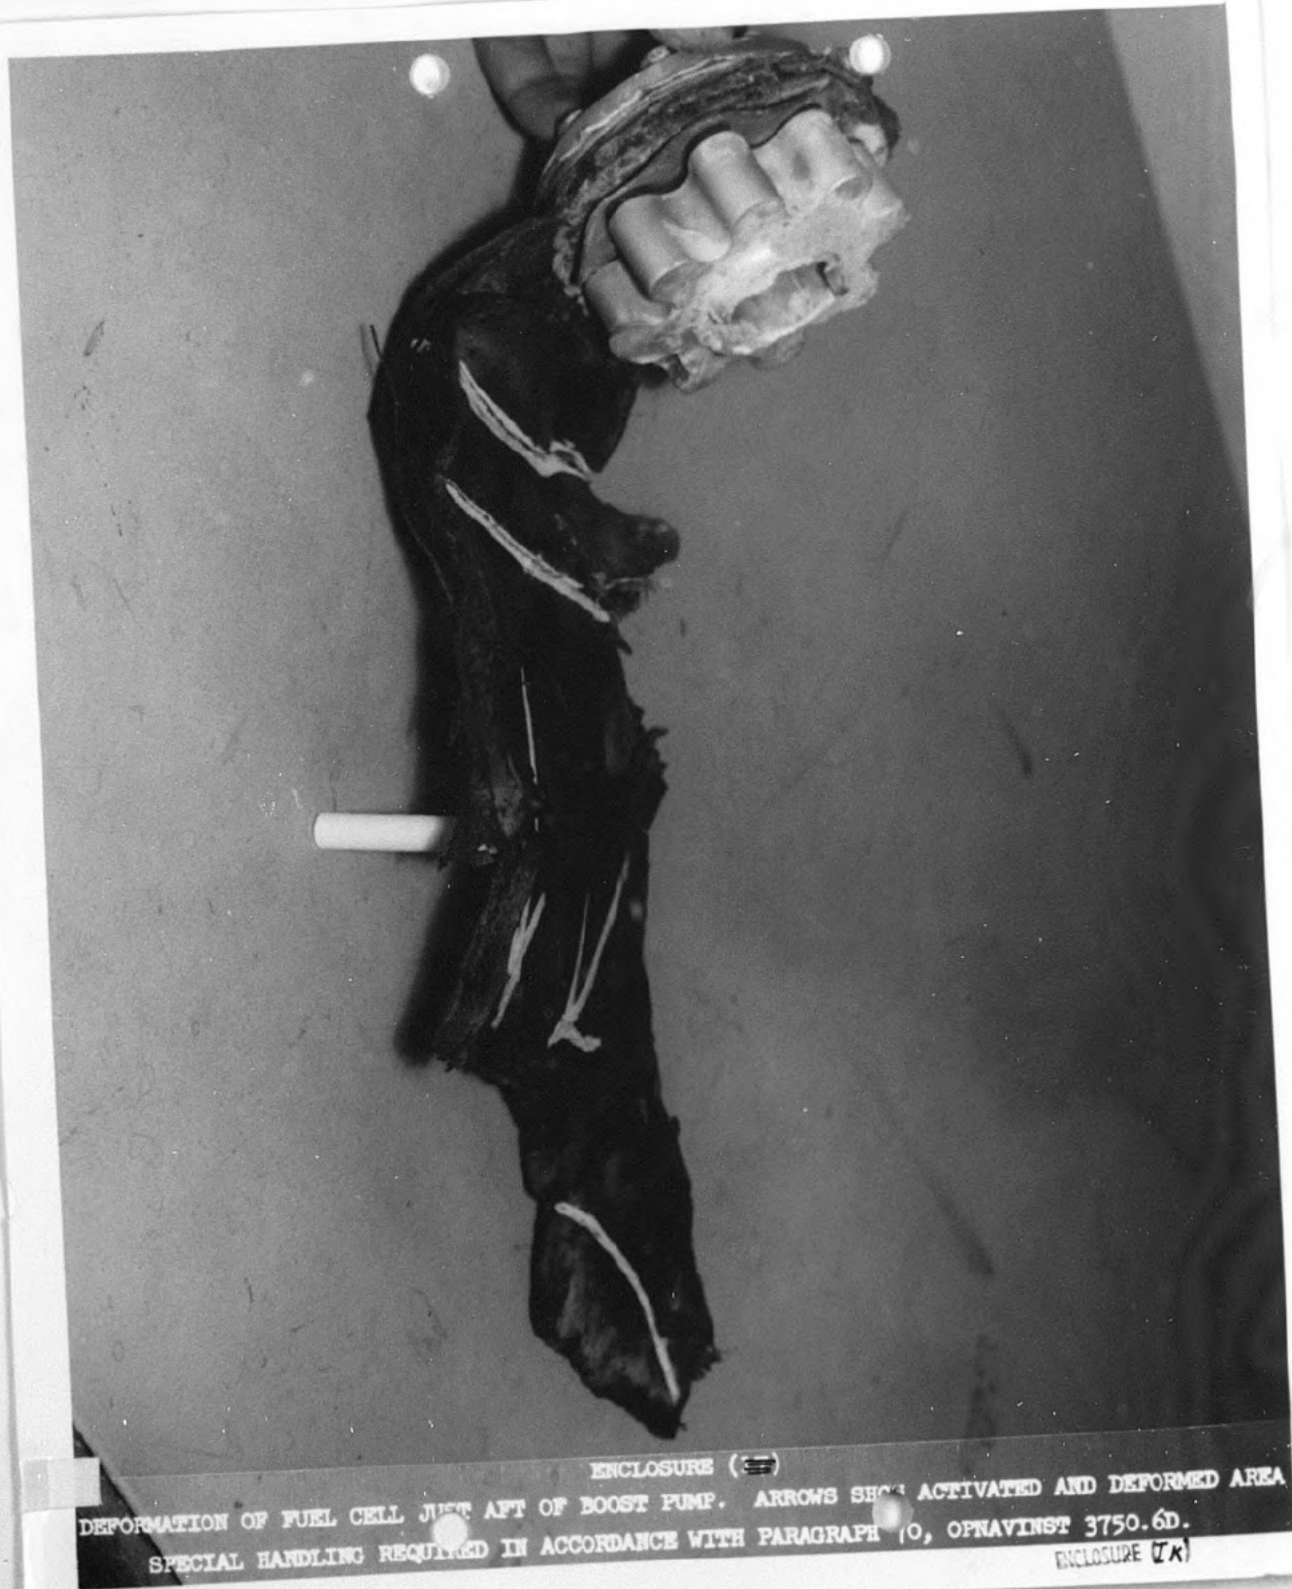
DEFORMATION OF FUEL CELL JUST AFT OF BOOST PUMP. ARROWS SHOW ACTIVATED AND DEFORMED AREA
SPECIAL HANDLING REQUIRED IN ACCORDANCE WITH PARAGRAPH 10, OPNAVINST 3750.6D.

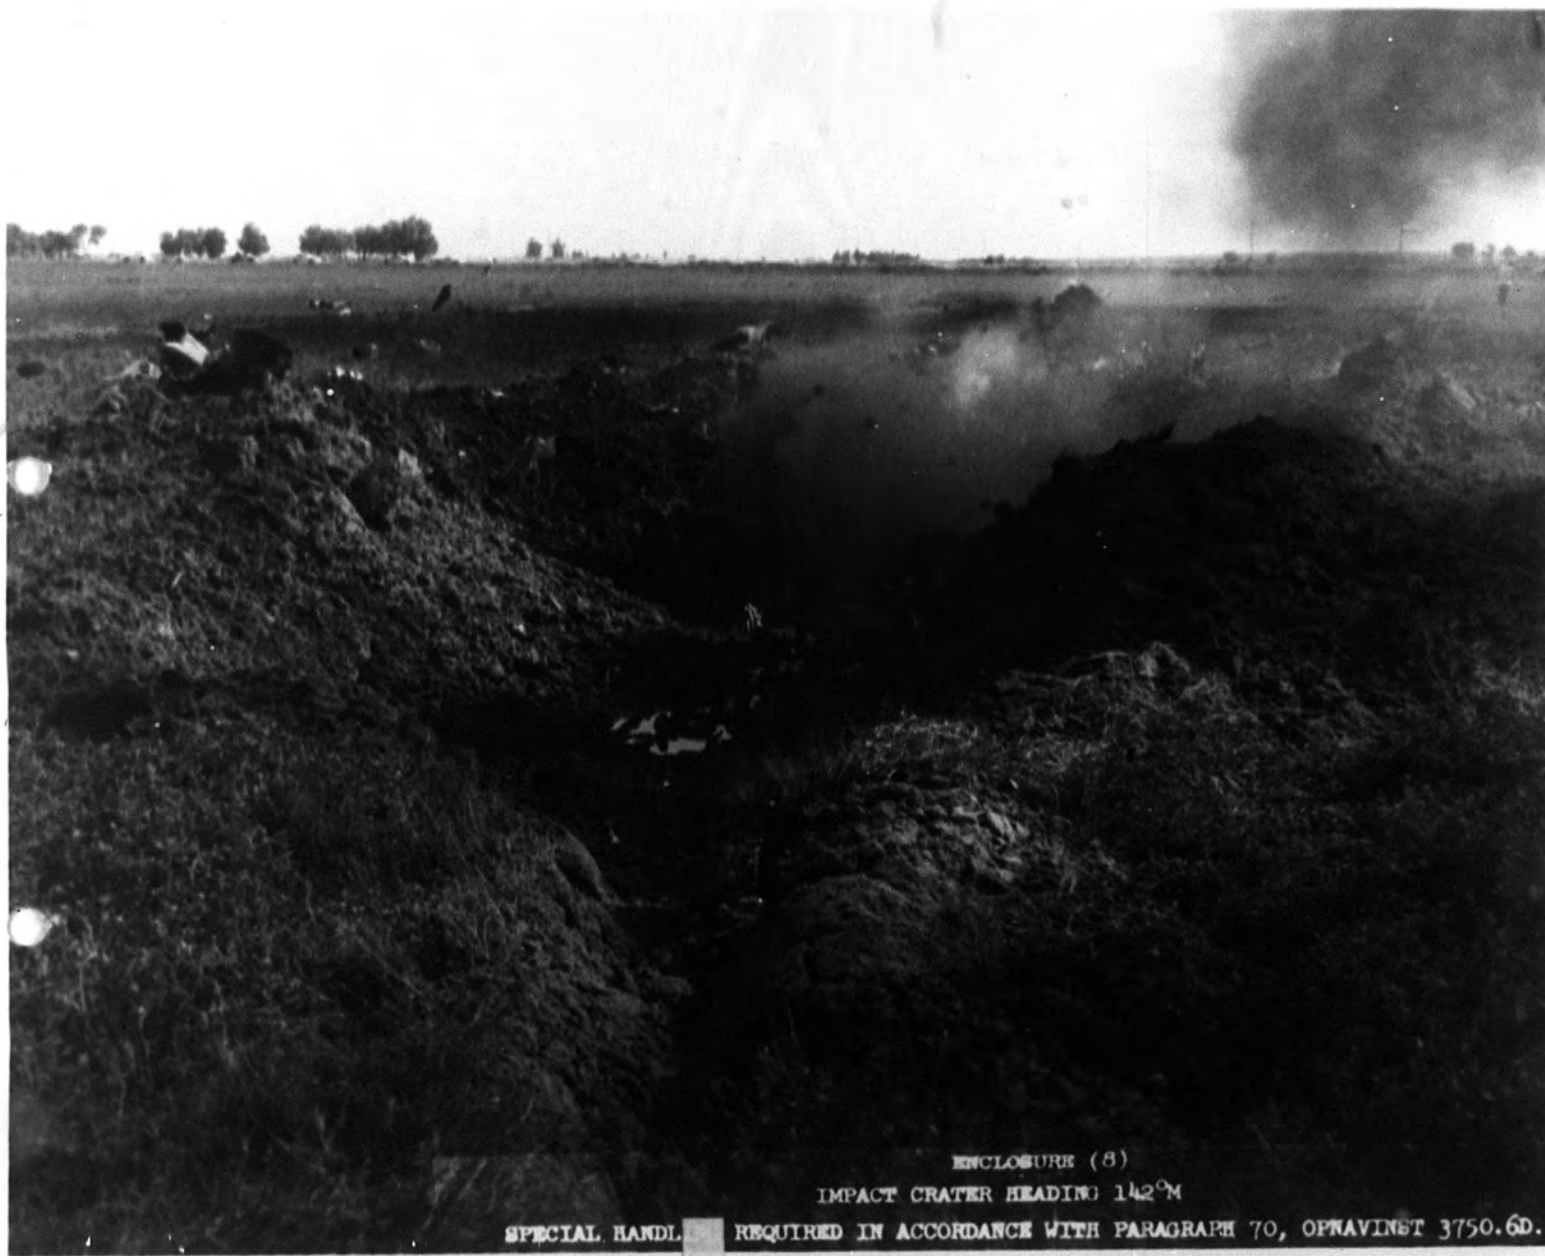
ENCLOSURE (8)

IMPACT CRATER HEADING 142°M

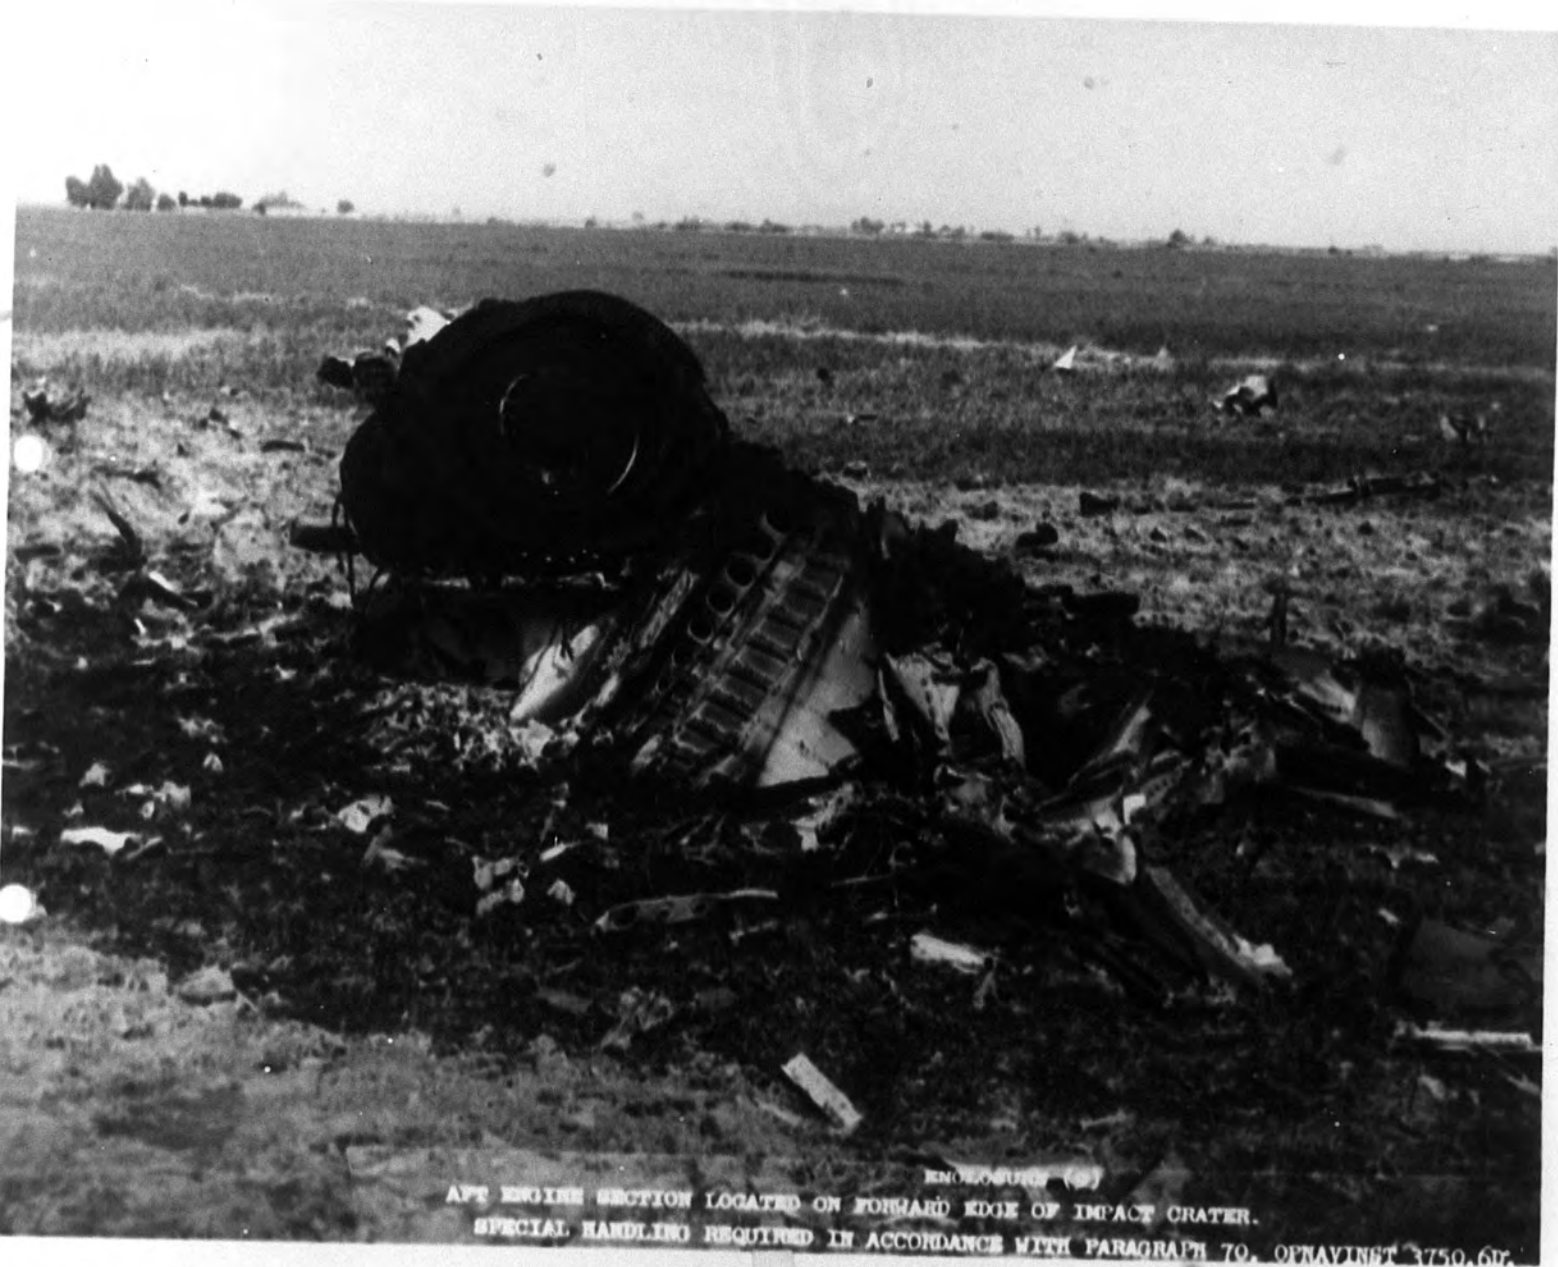
ENGINE SECTION (2)
AFT ENGINE SECTION LOCATED ON FORWARD EDGE OF IMPACT CRATER.
SPECIAL HANDLING REQUIRED IN ACCORDANCE WITH PARAGRAPH 70, OPNAVINST 3750.60.
